U.S. Army
Coast. Eng. Res.
Ctr.

Features of Various Offshore Structures

MISCELLANEOUS PAPER NO. 3-75

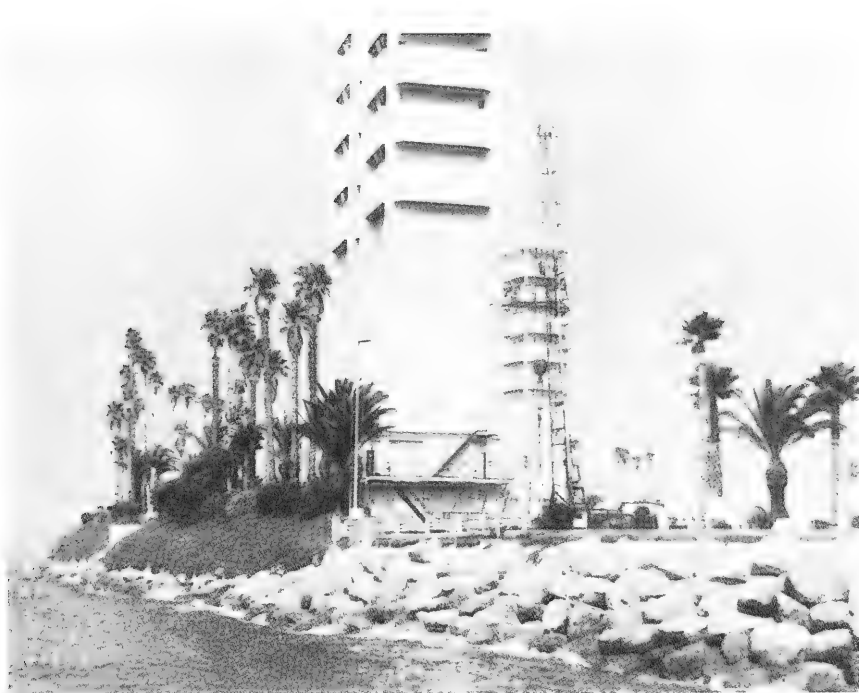
Figure 10. Typical view of island shoreline showing landscaping along top of armor protection and buildup of encircling berm to conceal most of the operational activity from the mainland. Note the camouflage of main drill derricks in decorative towers (August 1973).

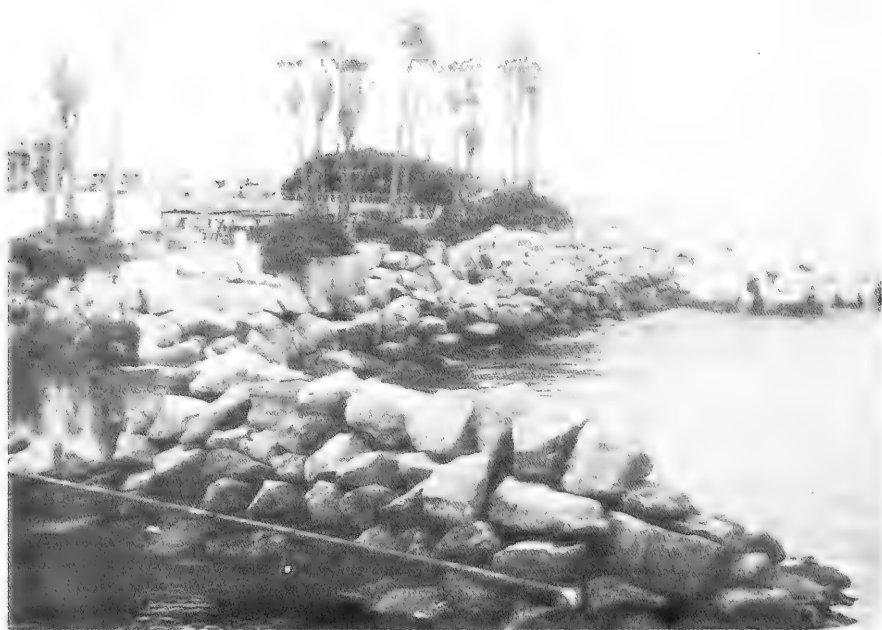
Figure 15. View of north side of island showing unusual configuration and good condition of armor rock (August 1973).

(b) Unusual Features. The unusual configuration developed from the attempt to obtain best wave protection (Fig. 15). To obtain the most economical but adequate design, extensive studies were conducted to determine most suitable configuration and orientation. The peculiar, partially protected aspect of the site seemed only to introduce additional factors for consideration in these studies and led to the concept of the more protective seaward face to resist the larger waves.

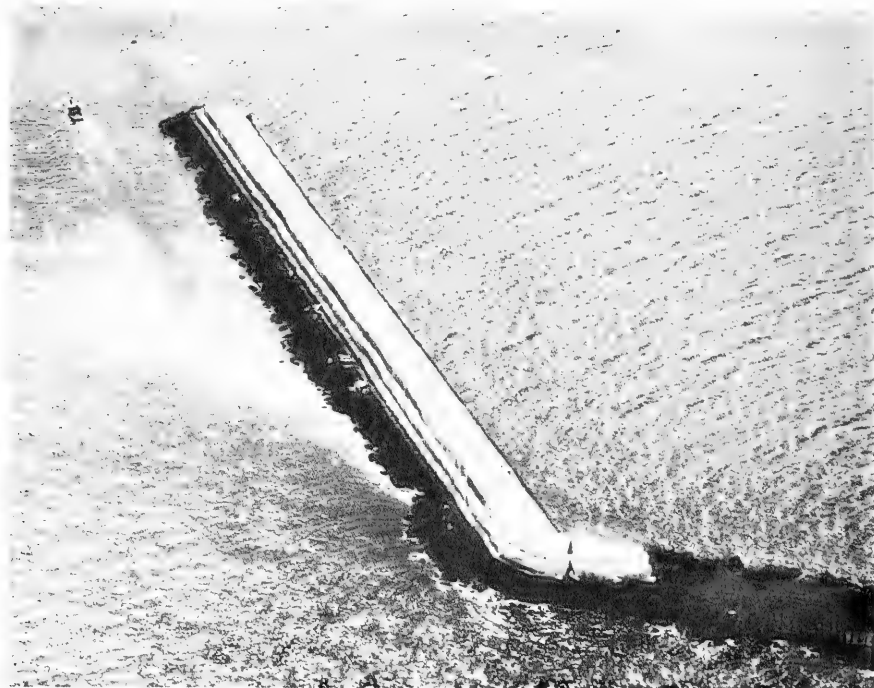
Figure 20. Aerial view of Sandy Bay Breakwater (1967).

(b) Type. Rubble-stone mound substructure surmounted by a sloped stone block superstructure with 20- to 30-ton granite cap stones and 10-ton apron stones (Fig. 20).

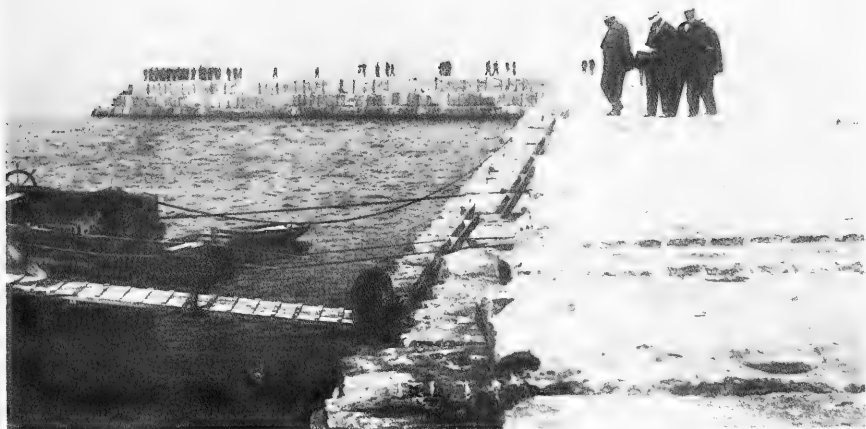
Figure 23. Looking north along the granite block superstructure of the breakwater (1916).

(b) Unusual Features. Workmanship and craftsmanship exhibited in breakwater superstructure of uniform-cut granite blocks laid flat and in horizontal courses (Fig. 23).

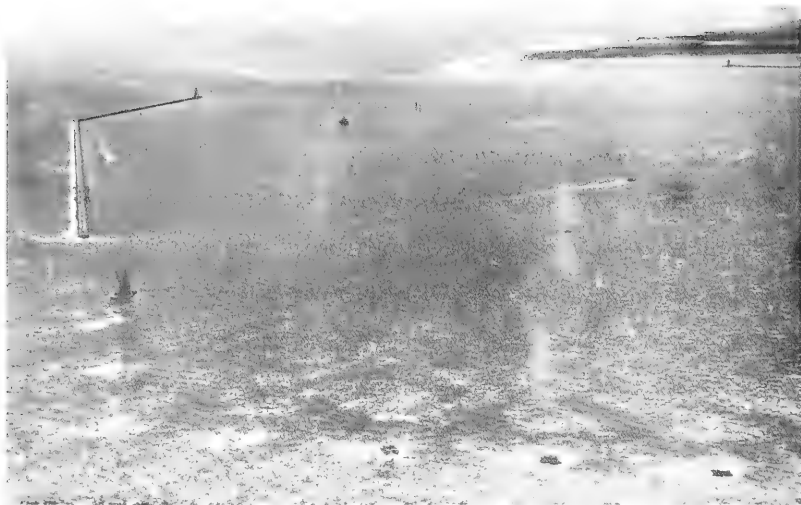
Figure 24. Aerial view southeastward toward Cape Henlopen. Ice piers in foreground and outer breakwater at left; old breakwater close inshore at right (U.S. Army Engineer District, Philadelphia—in press, 1974).

(b) Type. Rock mound (Fig. 24).

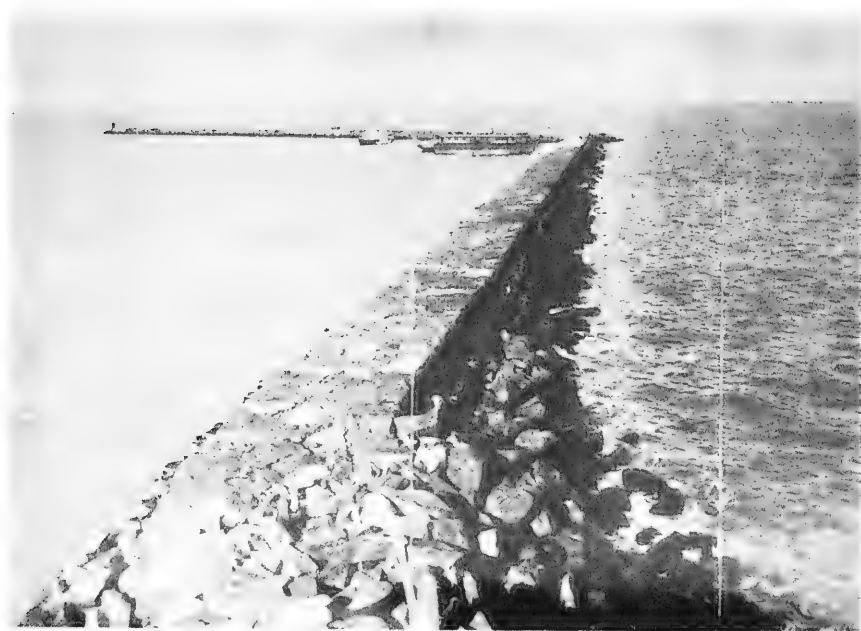
Figure 32. View northward along top of "Gap" construction with ice breaker in background (photo taken in 1890's). Note relatively calm water on harbor side (U.S. Army Engineer District, Philadelphia—in press, 1974).

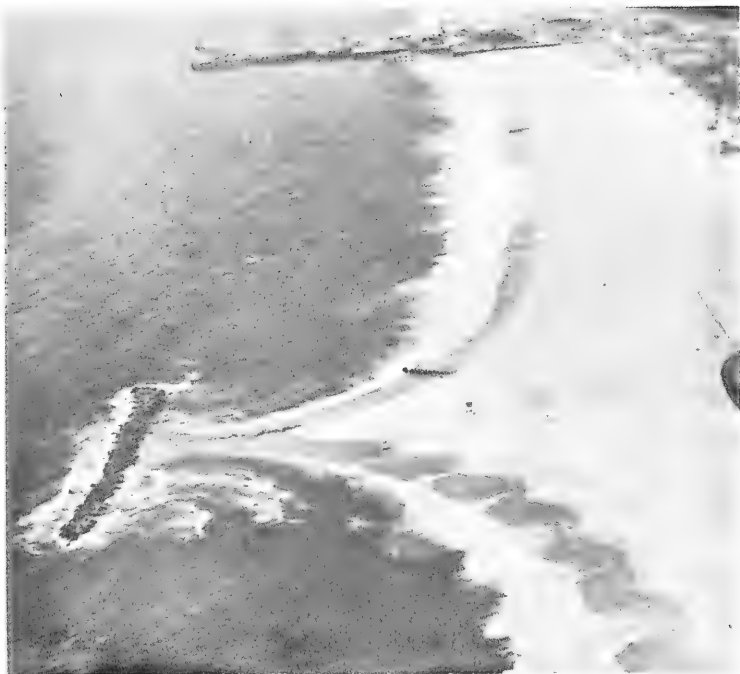
Figure 34. Aerial oblique photo of Venice Breakwater (Inman and Frautschy, 1965).

(b) Type. Rock mound (Fig. 34).

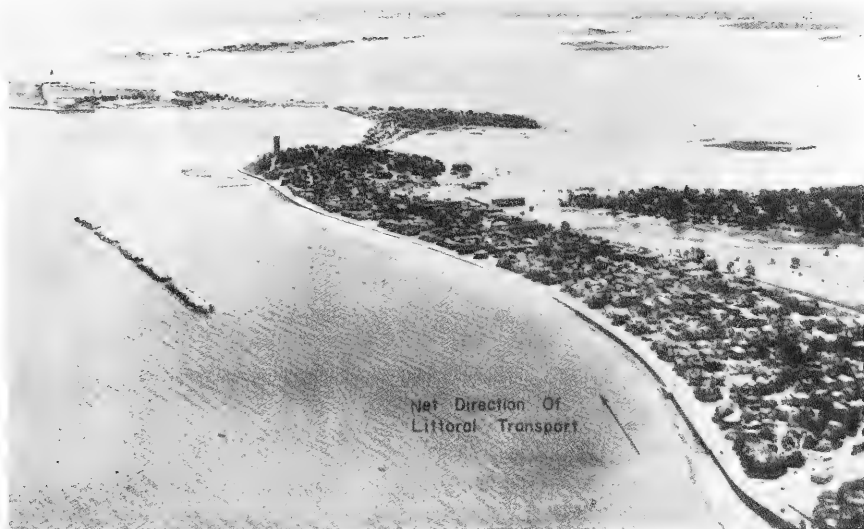
Figure 37. View of breakwater from northeast, (1949) (U.S. Army, Corps of Engineers, Coastal Engineering Research Center, 1966).

(b) Type. Rubble-mound breakwater (granite) (Fig. 37).

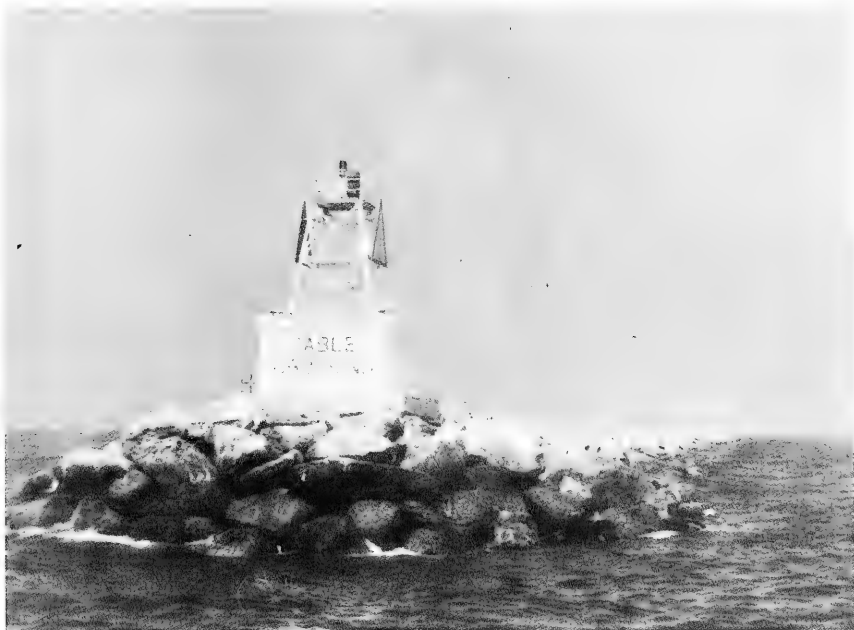
Figure 41. View of west end of middle breakwater (August 1973).

(2) Type. Sand and clay mound covered with rock blankets (Fig. 41).

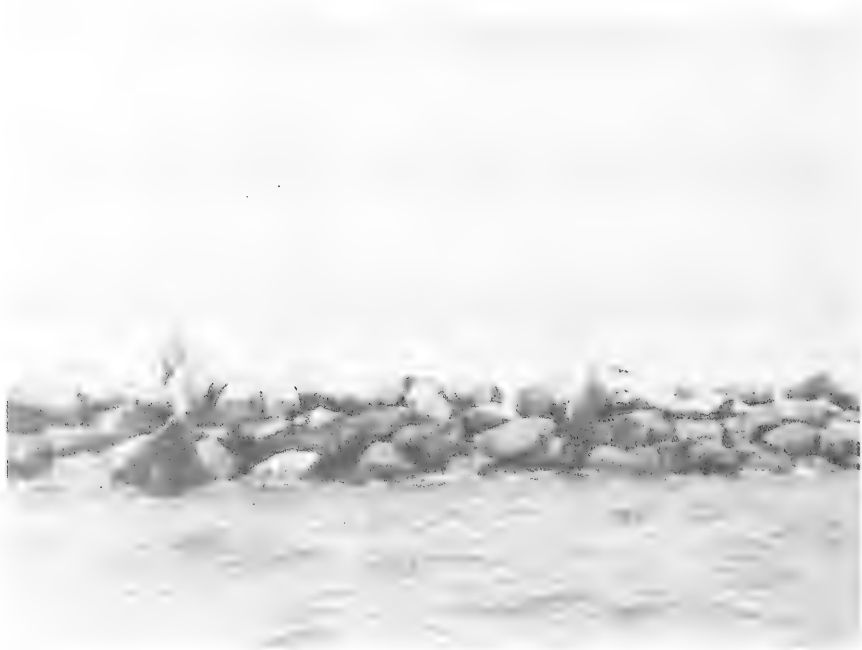
Figure 45. View on ocean side of middle breakwater showing displaced capstones (August 1973).

(1) Performance. No indication of failure, although a single capstone in various locations has been upended due to wave action. In 1968, at one point near the eastern end of the middle breakwater, a ship struck the breakwater from the ocean side, dislodging several stones (Fig. 45). Since no further damage was apparent, no repair has been undertaken. Settlement due to breakwater construction has been negligible.

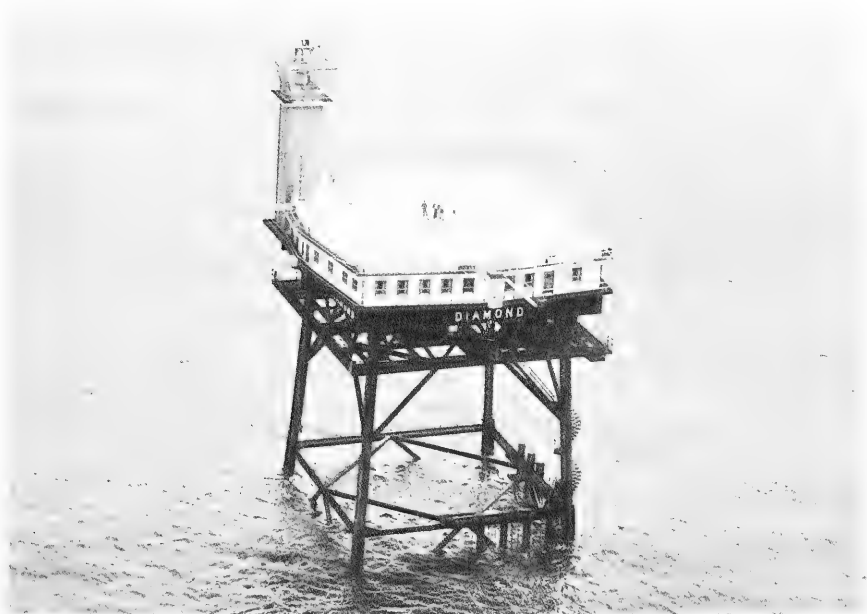
Figure 46. Aerial view of Diamond Shoals Light Station.

(2) Type. Pile-supported jacket-type structure (Fig. 46). Steel piles driven through a prefabricated steel-trussed template. Superstructure of prefabricated sections.

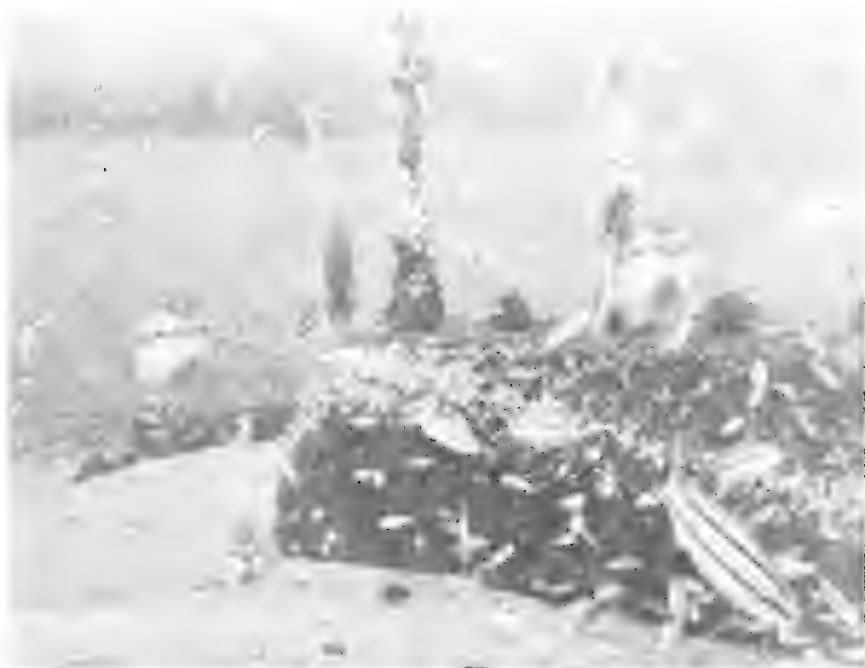
Figure 48. View showing marine life beneath tower.

(2) Biota. No recorded data. Several underwater inspections have reported heavy marine growth on the structure and that fish are attracted to the structure (Fig. 48). Occupants report birds are also attracted.

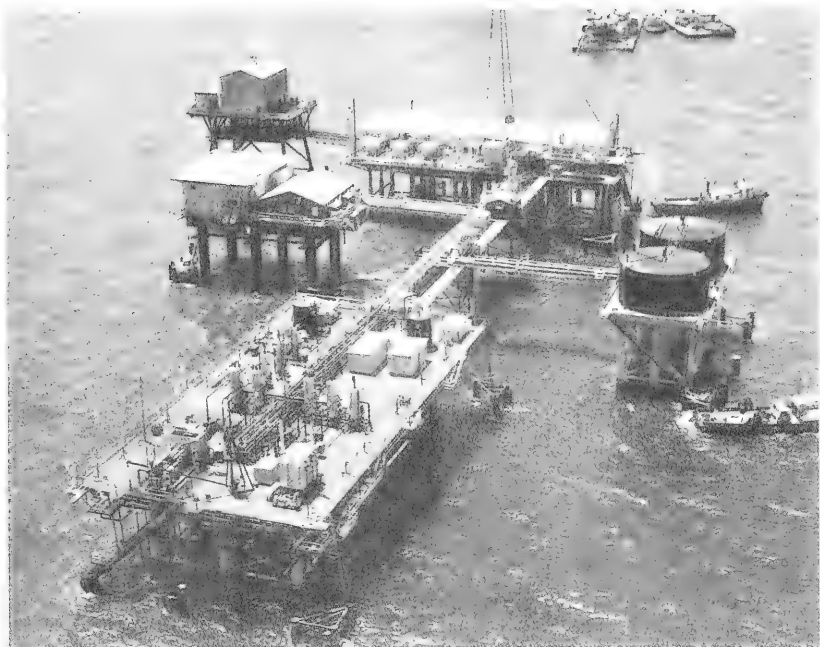
Figure 49. Aerial view of Eugene Island area facilities.

(2) Type. Concrete platform supported on concrete piles driven with concrete template (Fig. 49).

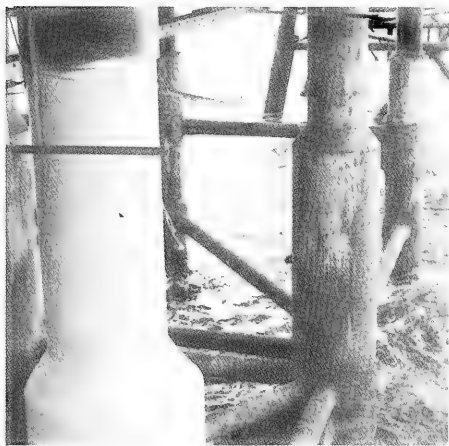
Figure 54. View of oil storage platform showing concrete jacket, piles, and deck (upper photo); bottom views show the concrete jackets and piles, with guniting steel pipe bracing.

(2) Maintenance. Regularly scheduled inspections are made of the structural areas of the platforms, including a divers' inspection of the underwater parts. The only deterioration noted has been the spalling off of the Gunitite coating on the steel collars and cross braces (Fig. 54). All piling and bracing between water surface and platform are regularly sandblasted and painted. This has been satisfactory in preventing corrosion of the bare steel, but the owner feels that using galvanized steel would be advisable in the future.

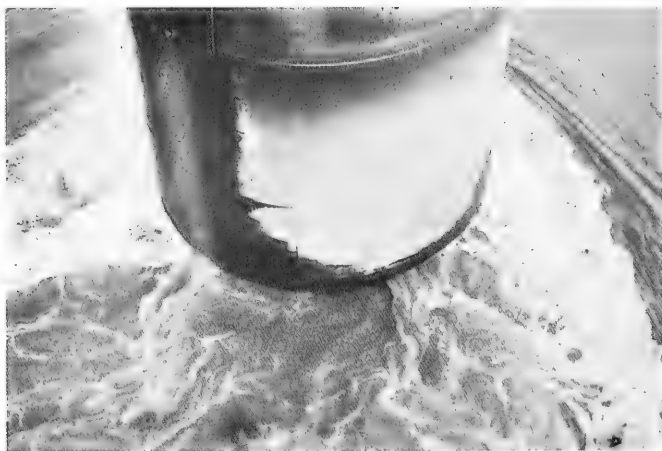
Figure 59. View showing effect of surface currents around "monopod" post (August 1973).

(7) Structural Performance (Fig. 59).
